Ad-hoc fire test on a mobile cooking stations local fire suppression system

Report detailing the findings of two fire tests conducted to assess the extinguishing performance of a local fire suppression system designed for use with a mobile cooking station

19th November 2019

FPA-00101813

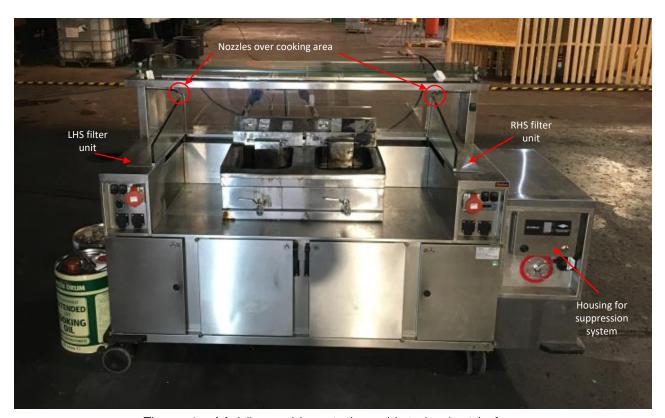
Figure 1 – Mobile cooking station with twin electric fryer

The system tested was Rieber's ACS Air Cleaning System, ACS 1600 mobile cooking station used with a twin electric fryer unit as shown in Figure 1. For the test programme, the system was supplied, setup and operated by Stirling Fire Solutions Limited.

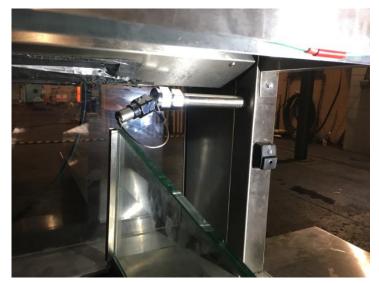
Figure 2 – Nozzle installed over the RHS of the cooking area

Installed in the cooking station was a prototype fire suppression system. The system used a pressurised canister containing 2.75 US gallon of wet chemical extinguishing agent. When activated the agent was discharged through and array of 4 spray nozzles. Two of the nozzles were directed over cooking area and two of the nozzles discharged into the filter housing. Under normal operating conditions the system is activated based on the response of an electronic linear heat detection system. However, for the test programme it was operated manually after a two minute delay (to exceed the LPS1223 protocol of 30 seconds and meet the UL300 protocol of 2 minutes) to ensure that the fire represented a challenging test to the system.

Photographs of a nozzle are shown in Figure 2 and Figure 3.

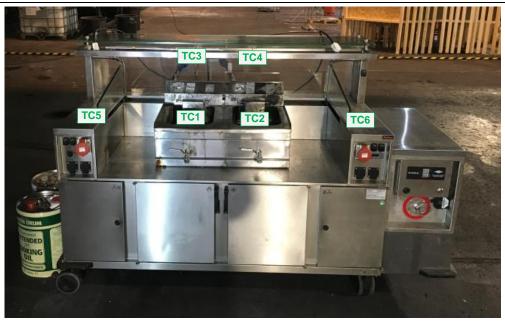
Thermocouple ID	Location
TC1	Temperature of oil in LHS fryer
TC2	Temperature of oil in RHS fryer
TC3	Temperature in the proximity of the detection system above LHS fryer
TC4	Temperature in the proximity of the detection system above RHS fryer
TC5	Temperature in LHS filter unit housing
TC6	Temperature in RHS filter unit housing

Figure 4 – Thermocouple locations

Six type-k mineral insulated thermocouples were used to monitor temperatures in the cooking station. Details of thermocouple positions are shown below.

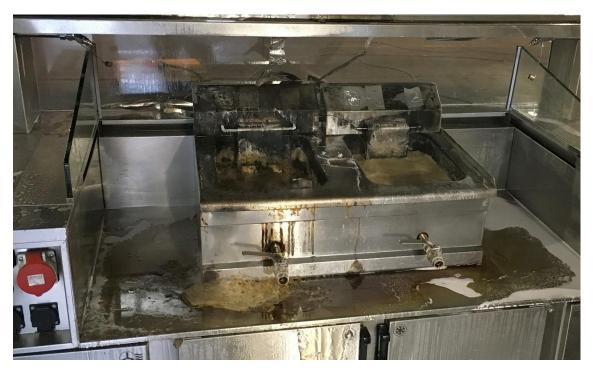
Figure 8 – Test 1, Cooking station post-test

Test 1 was conducted with the cooking station fans operating. The system extinguished the fire in the cooking area within 2 seconds of its operation.

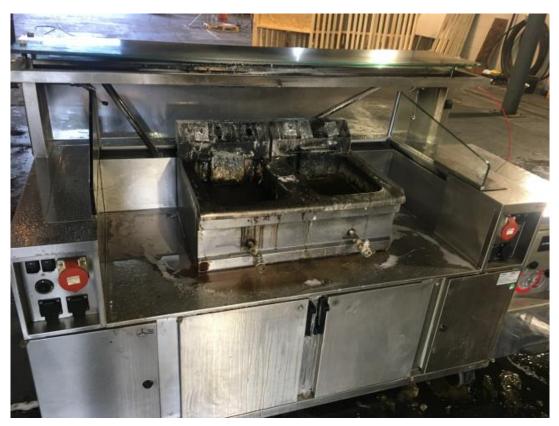
Figure 12 – Test 2, Cooking station post-test

Test 2 was conducted with the fans switched off. The system extinguished the fire in the cooking area within 2 seconds of its operation.
